WETLAND DELINEATION REPORT
CORRIDOR CENTER
CITY OF LAUREL, MARYLAND

TNT PROJECT NO.: 2807

PULTE GROUP

JULY 11, 2022

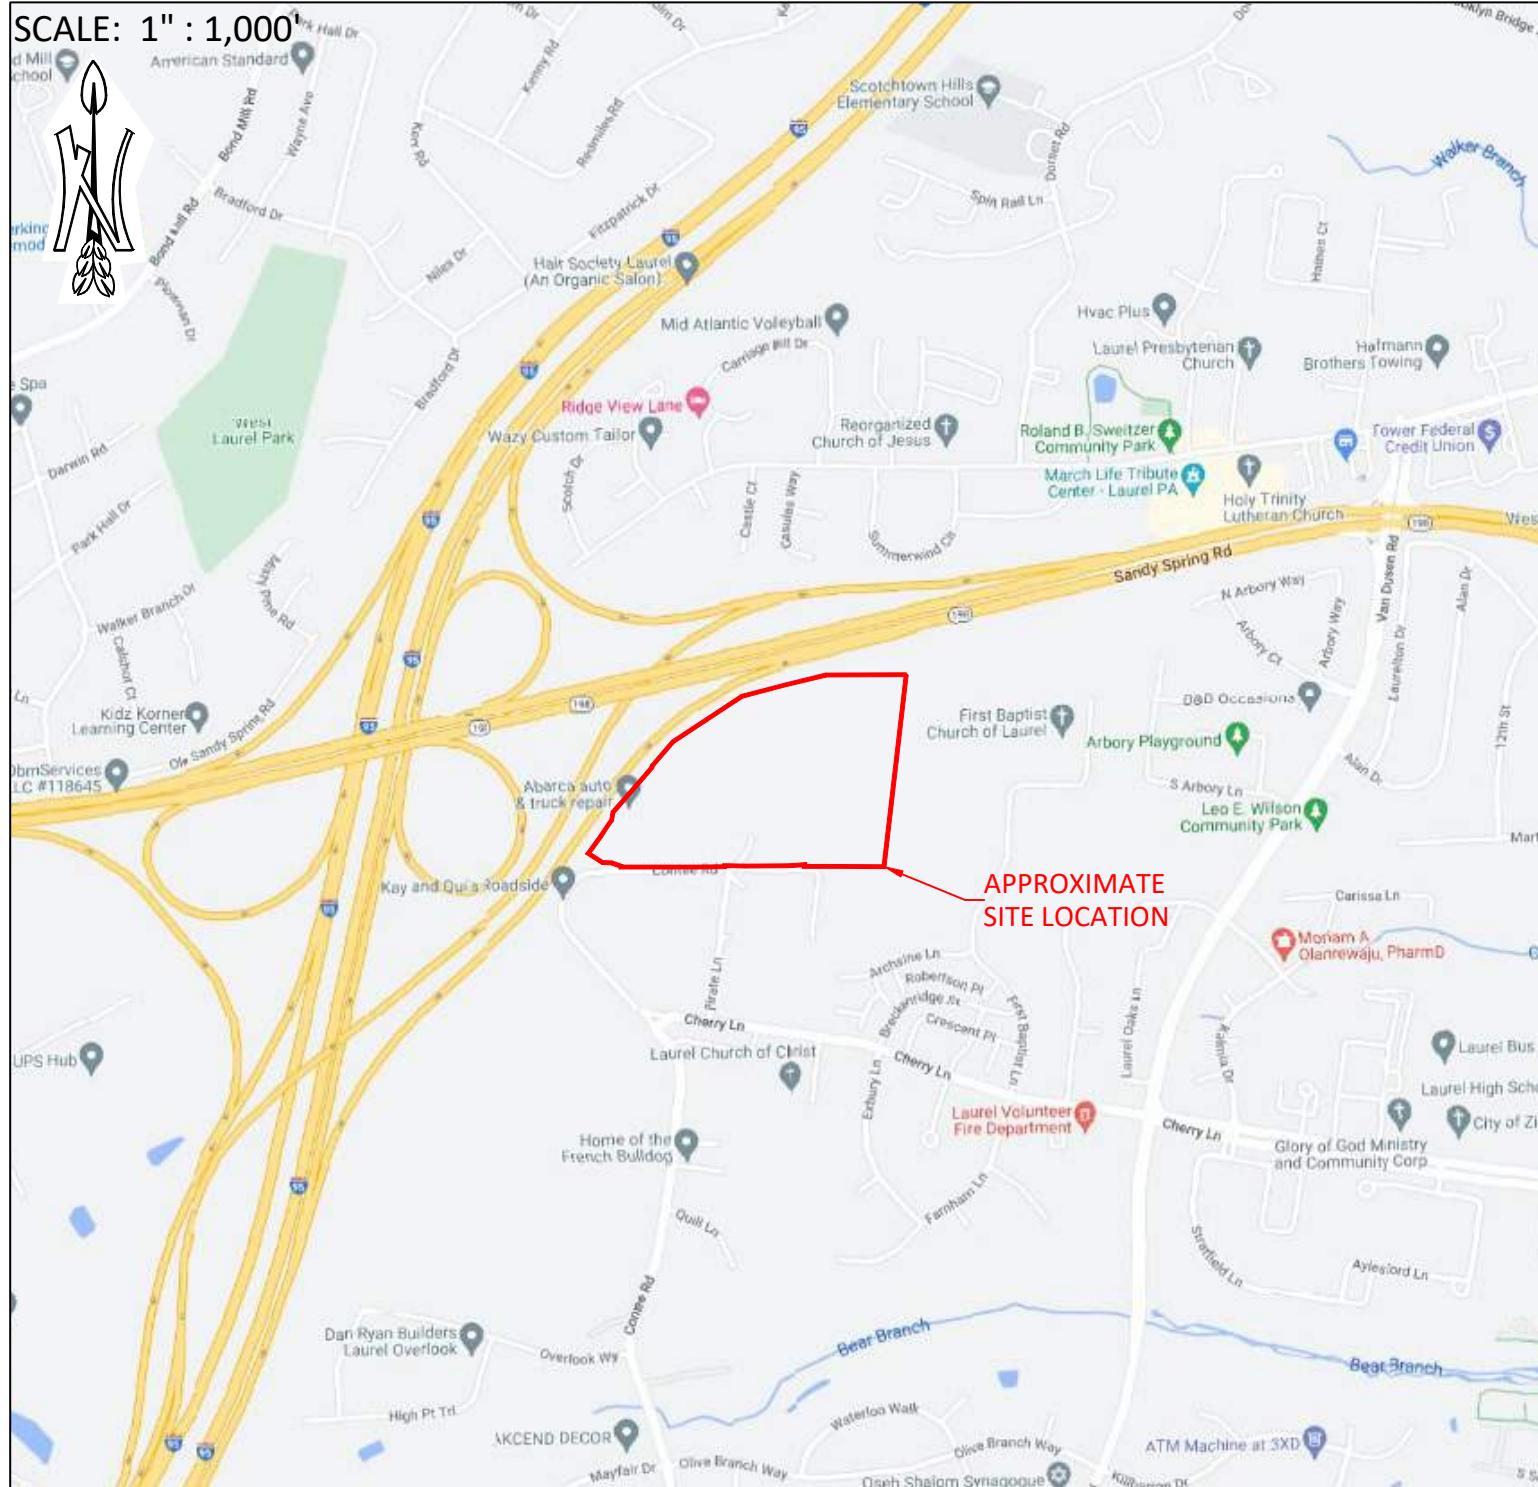
FIGURE 1

SITE LOCATION MAP

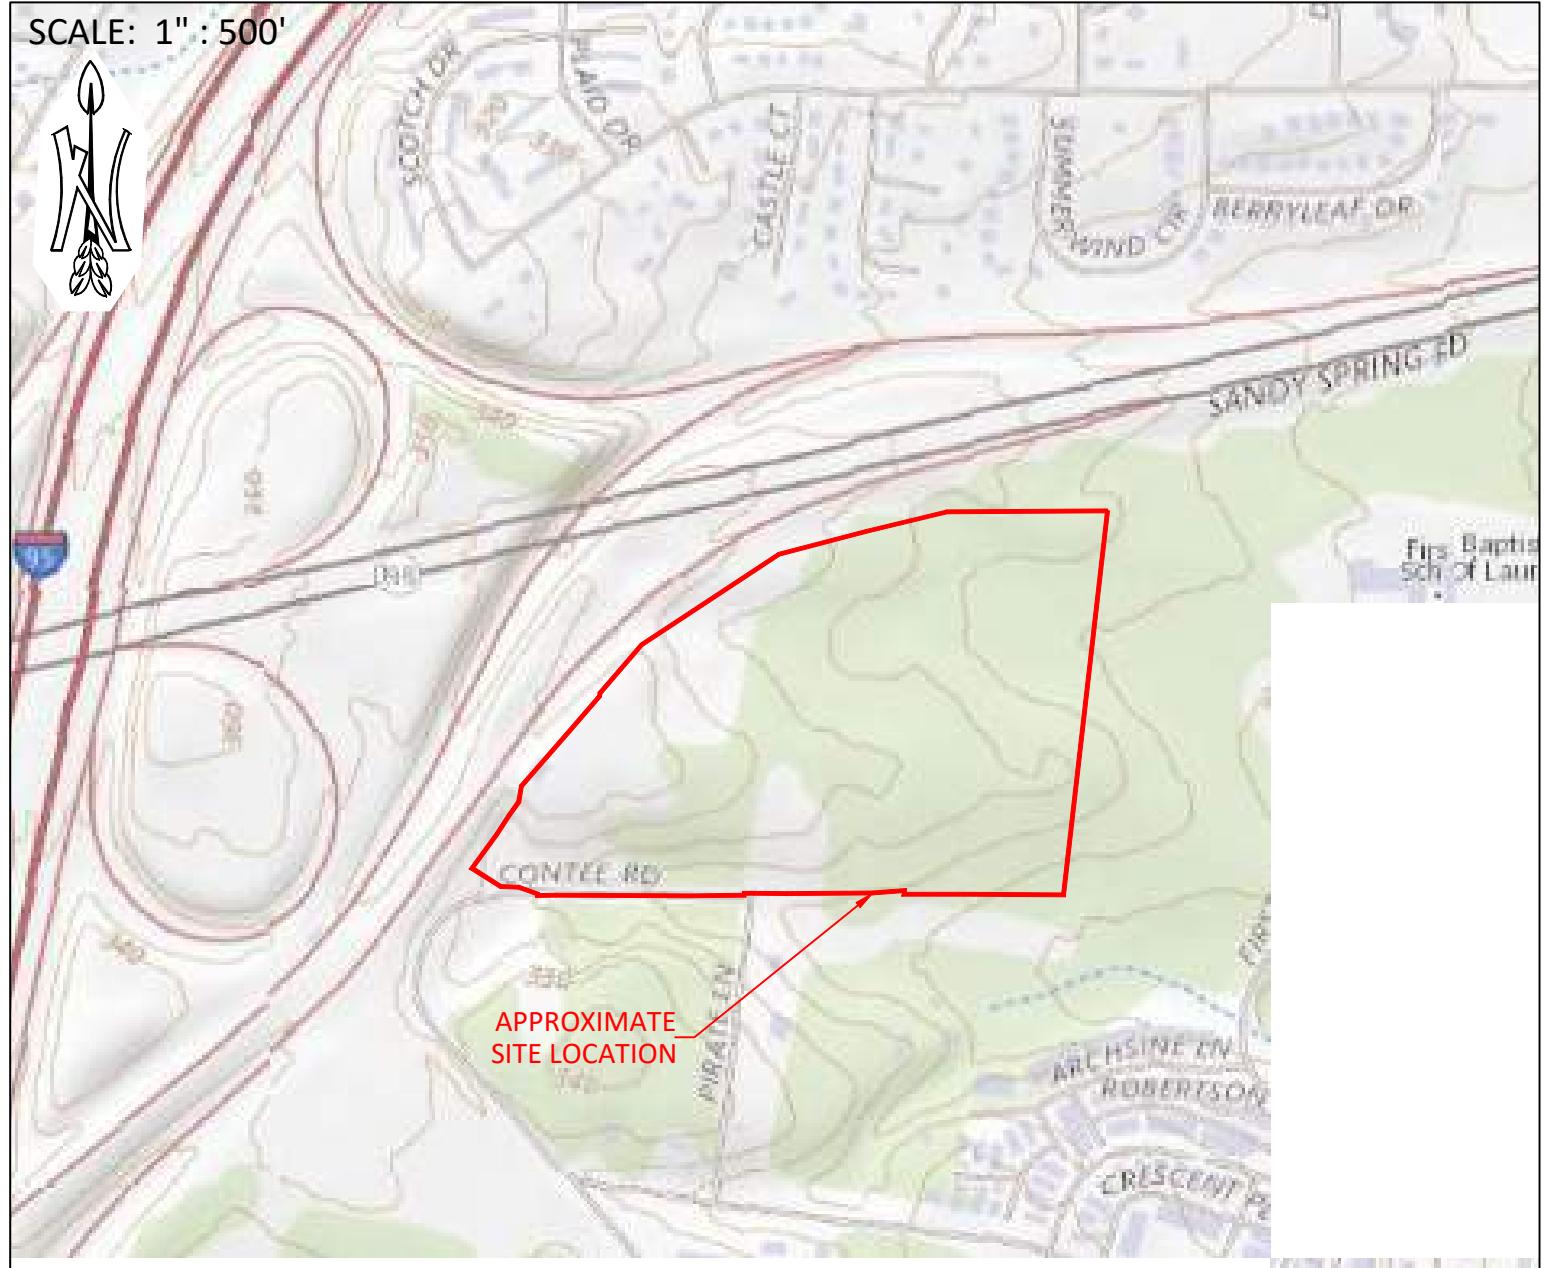
FIGURE 2

The USGS Beltsville quadrangle map shows elevations of approximately 280 to 330 feet above mean sea level (MSL). As shown on the USGS Map, the project site drains generally southeast to Crow Branch, located within the Patuxent watershed and identified as Hydrologic Unit Code (HUC) 02060006. The NWI map does not depict wetland or riverine features within the project site boundaries.

BELTSVILLE, MD USGS
TOPOGRAPHIC MAP

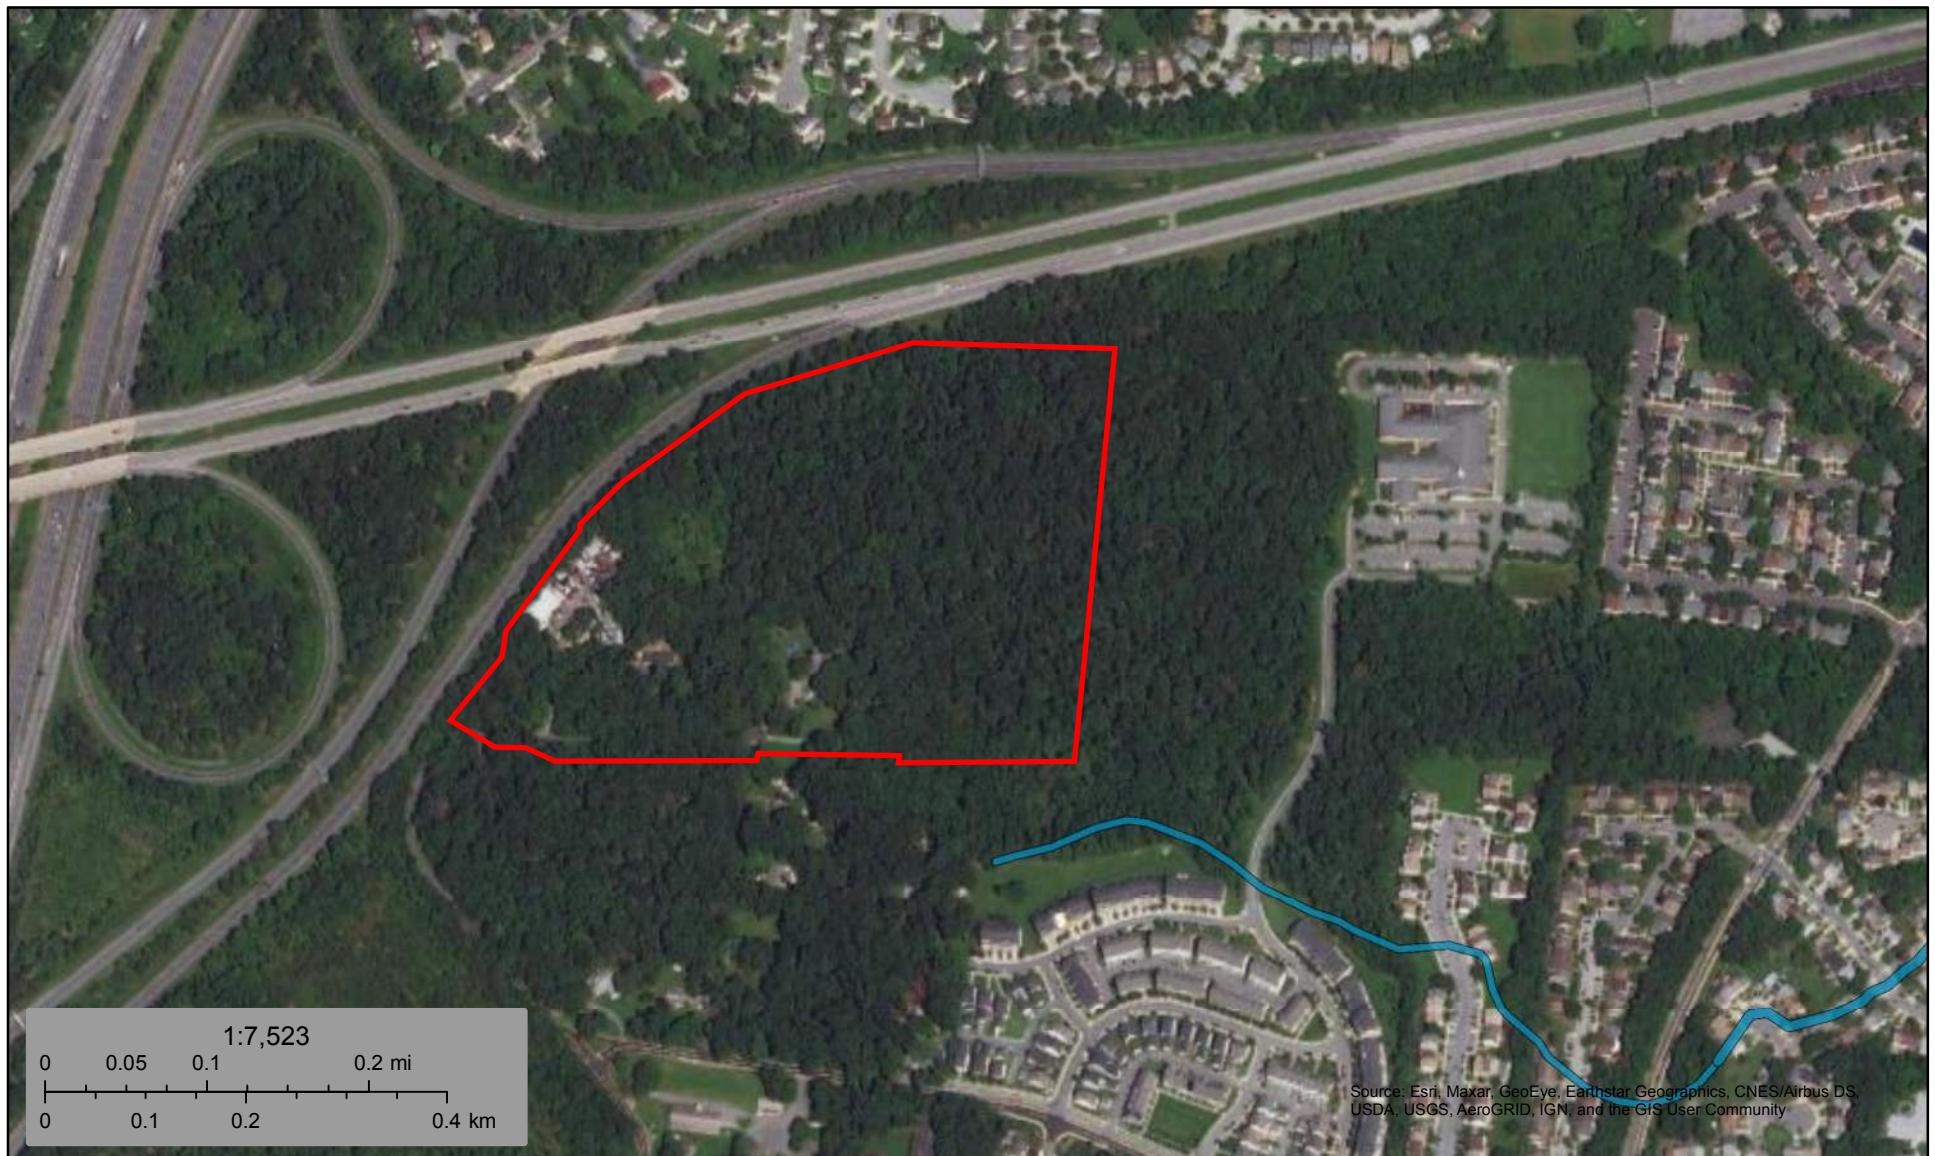
National Wetlands Inventory

Corridor Center

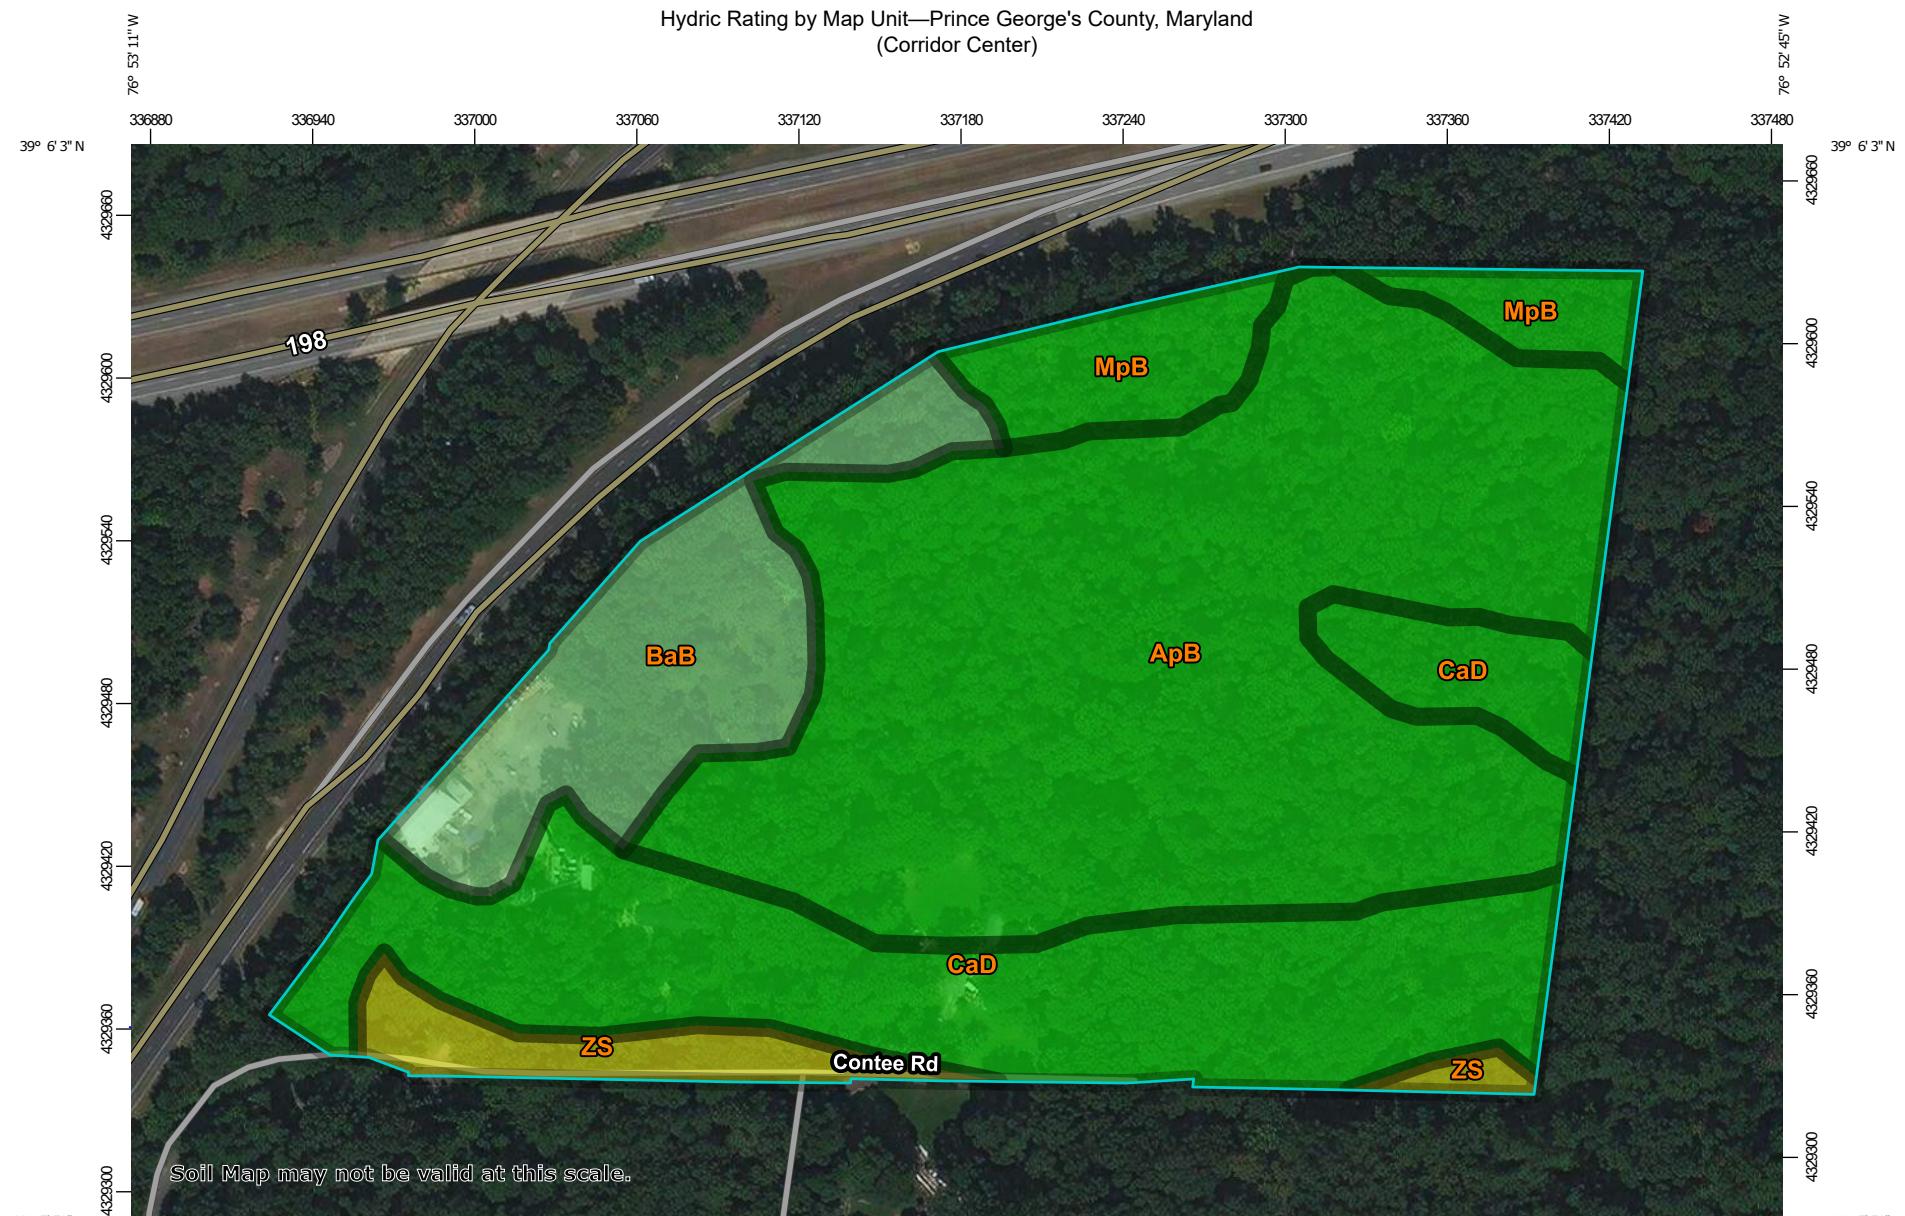
The soil survey indicates that the site is underlain primarily by Aquasco silt loam (ApB), Beltsville silt loam (BaB), Chillum silt loam (CaD), Matapeake silt loam (MpB), and Zekiah and Issue (ZS) soils. Zekiah and Issue soils (ZS) is classified by the NRCS as predominantly hydric.

Hydric Rating by Map Unit—Prince George's County, Maryland
(Corridor Center)

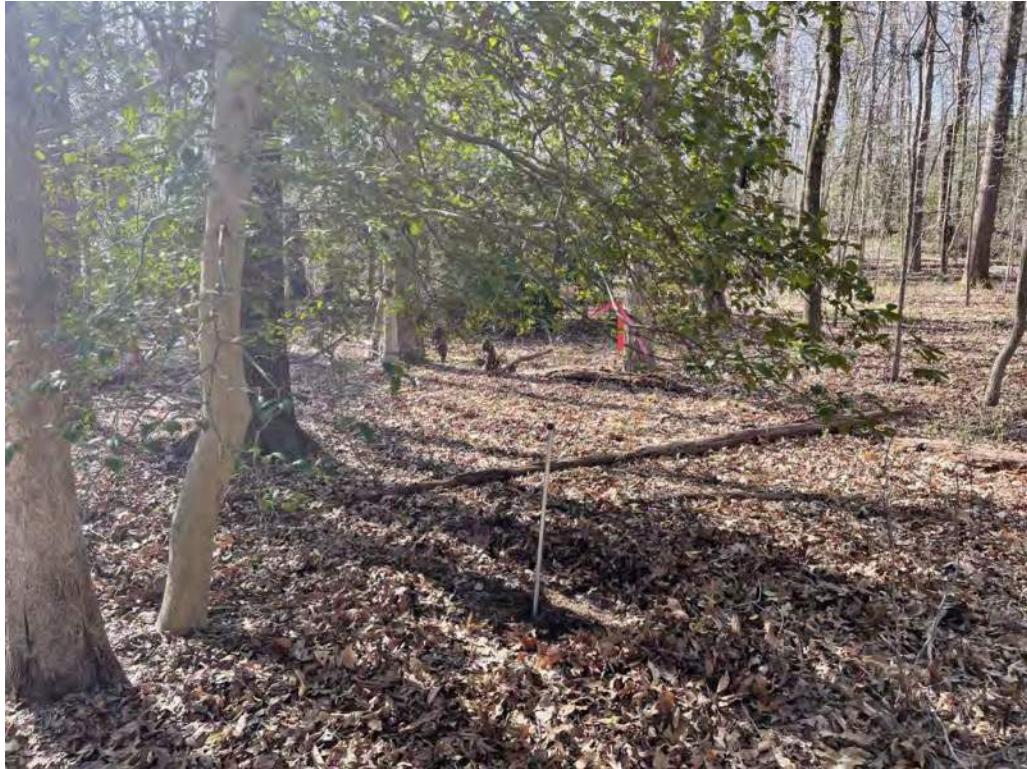
Hydrophytic Vegetation Present? Yes _____ No <input checked="" type="checkbox"/> Hydric Soil Present? Yes _____ No <input checked="" type="checkbox"/> Wetland Hydrology Present? Yes _____ No <input checked="" type="checkbox"/>	Is the Sampled Area within a Wetland? Yes _____ No <input checked="" type="checkbox"/>
Remarks: Upland data point taken outside flag A-8.

Photograph 1: View to the northeast showing the forested uplands at DP-1, taken outside flag A-8 within the northeastern portion of the project site.

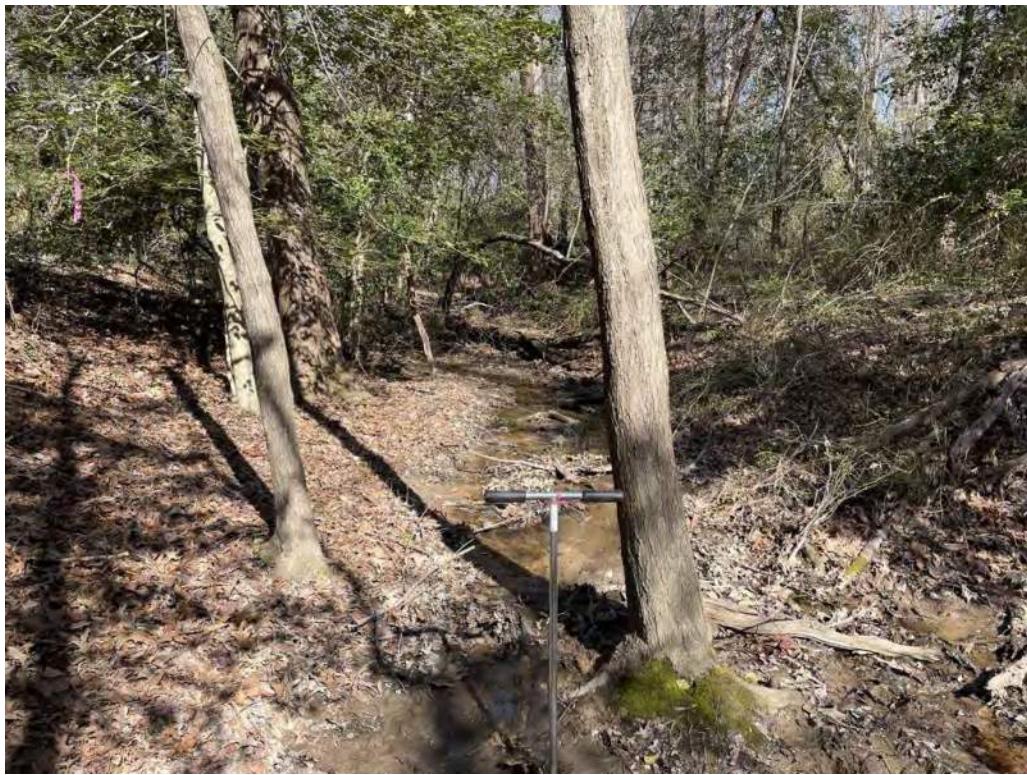
Hydrophytic Vegetation Present? Yes <input checked="" type="checkbox"/> No _____ Hydric Soil Present? Yes <input checked="" type="checkbox"/> No _____ Wetland Hydrology Present? Yes <input checked="" type="checkbox"/> No _____	Is the Sampled Area within a Wetland? Yes <input checked="" type="checkbox"/> No _____
Remarks: PFO data point taken inside flag A-15.

Photograph 2: View to the east showing the PFO wetland at DP-2, taken inside flag A-15 within the northeastern portion of the project site.

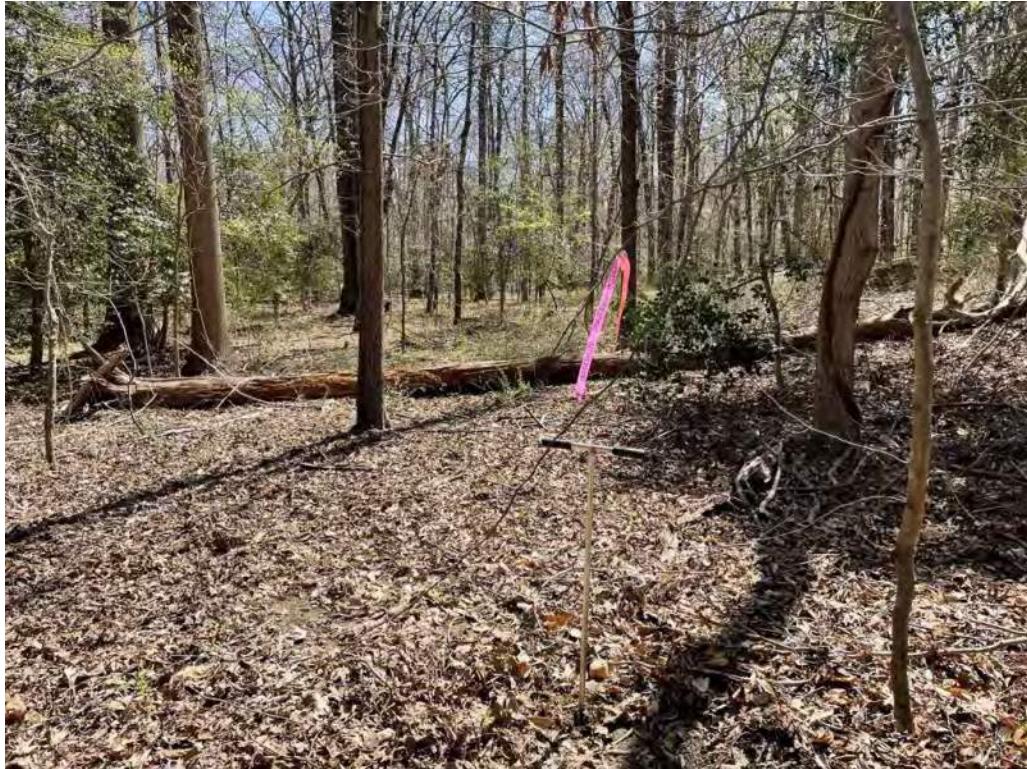
Photograph 3: View to the north showing the forested uplands at DP-3, taken outside flag A-32 within the northern portion of the project site.

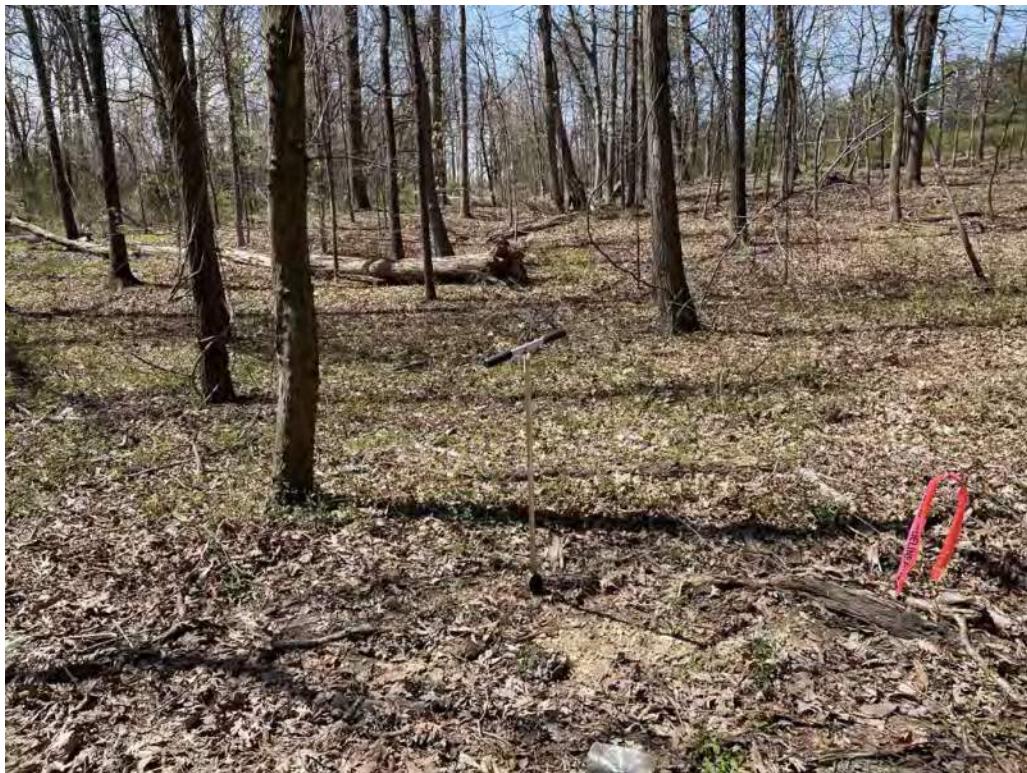
Photograph 4: View to the east showing the forested uplands at DP-4, taken outside flag G-4 within the southwestern portion of the project site.

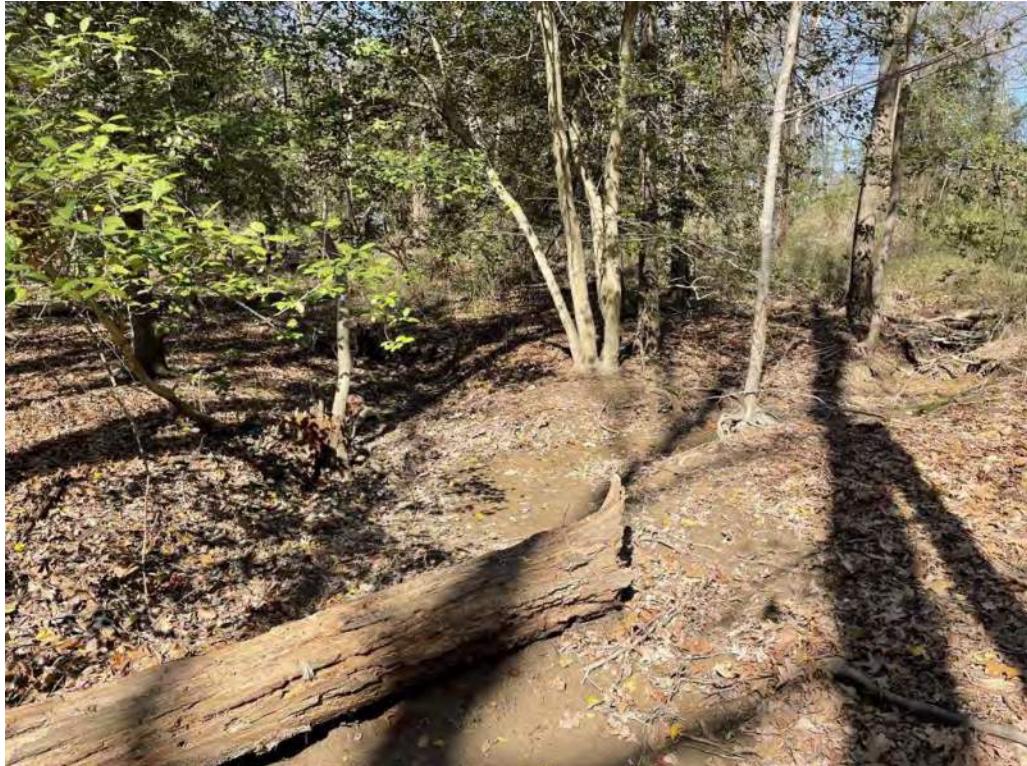
Photograph 5: View to the east showing the PFO wetland at flag A-23, taken within the northeastern portion of the project site.

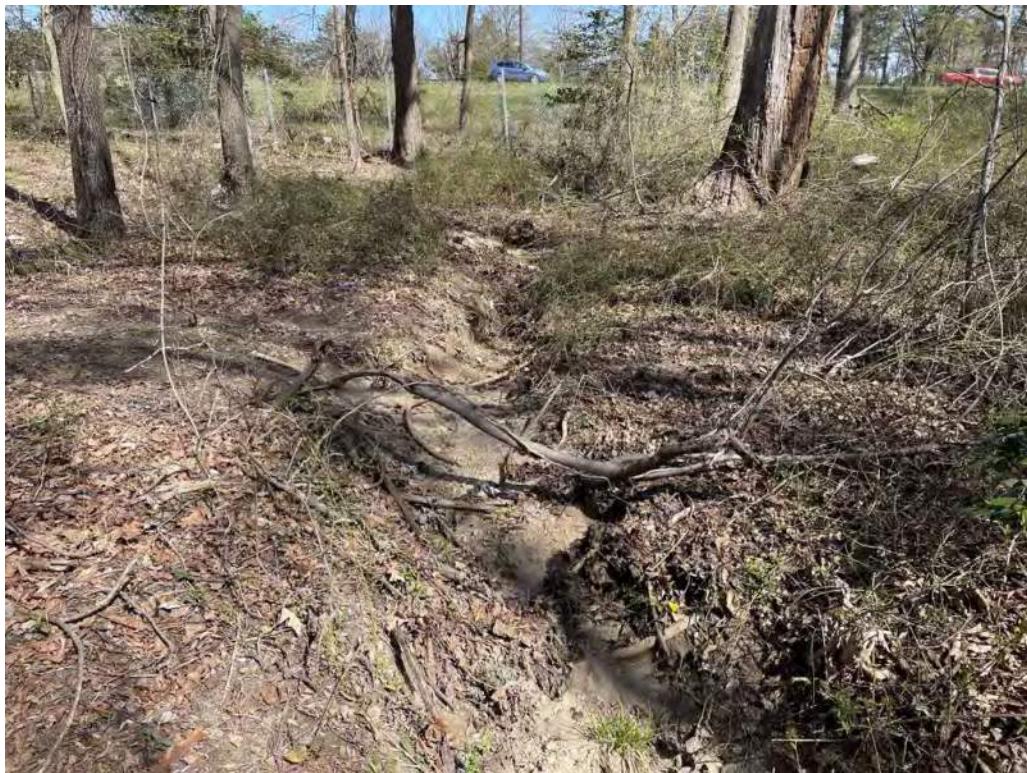
Photograph 6: View upstream to the north showing the ephemeral stream at flag E-7, taken within the northern portion of the project site.

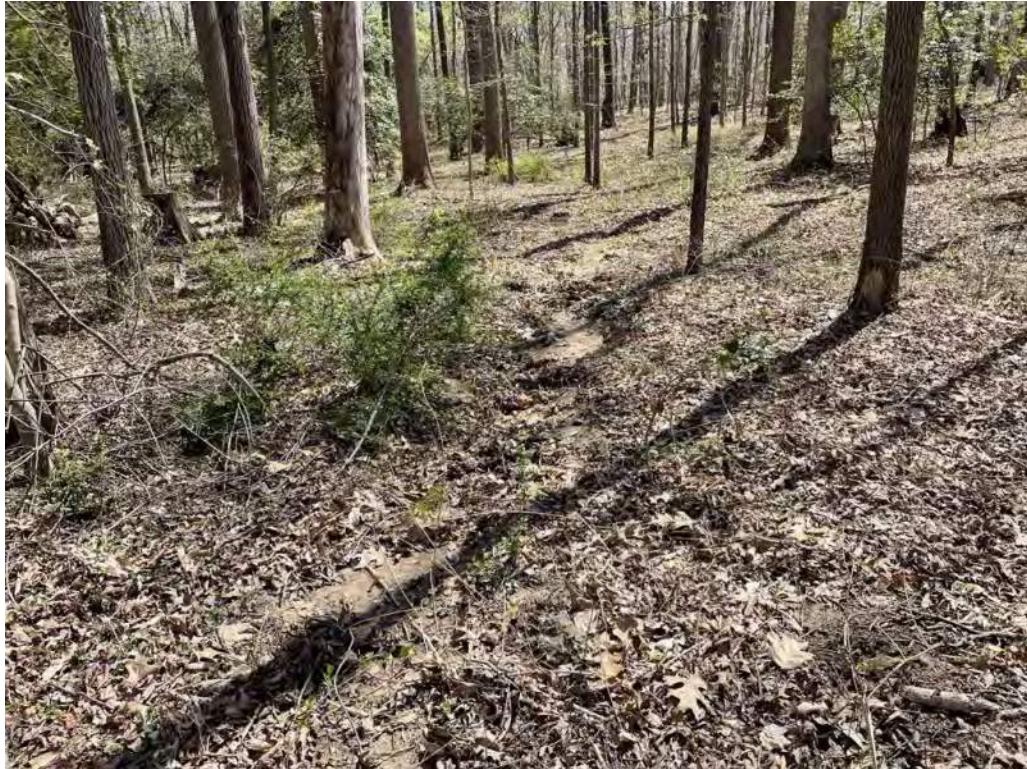
Photograph 7: View downstream to the south showing the ephemeral stream at flag A-39, taken within the northwestern portion of the project site.

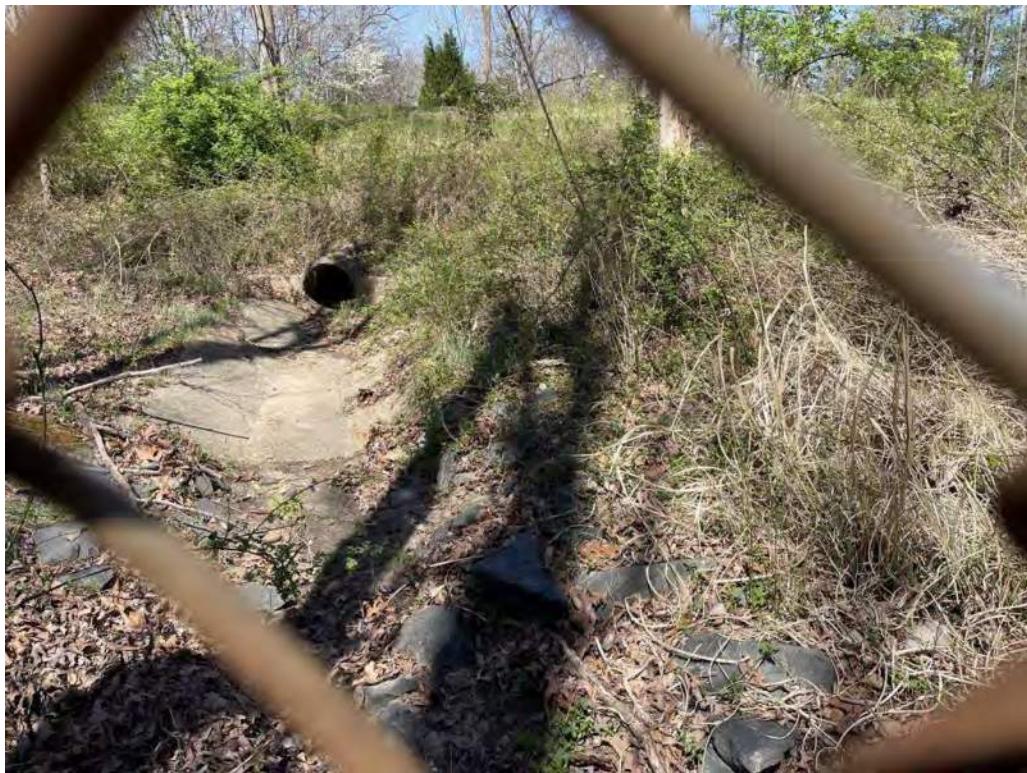
Photograph 8: View upstream to the north showing the existing culvert at flag A-54, taken within the northern portion of the site.

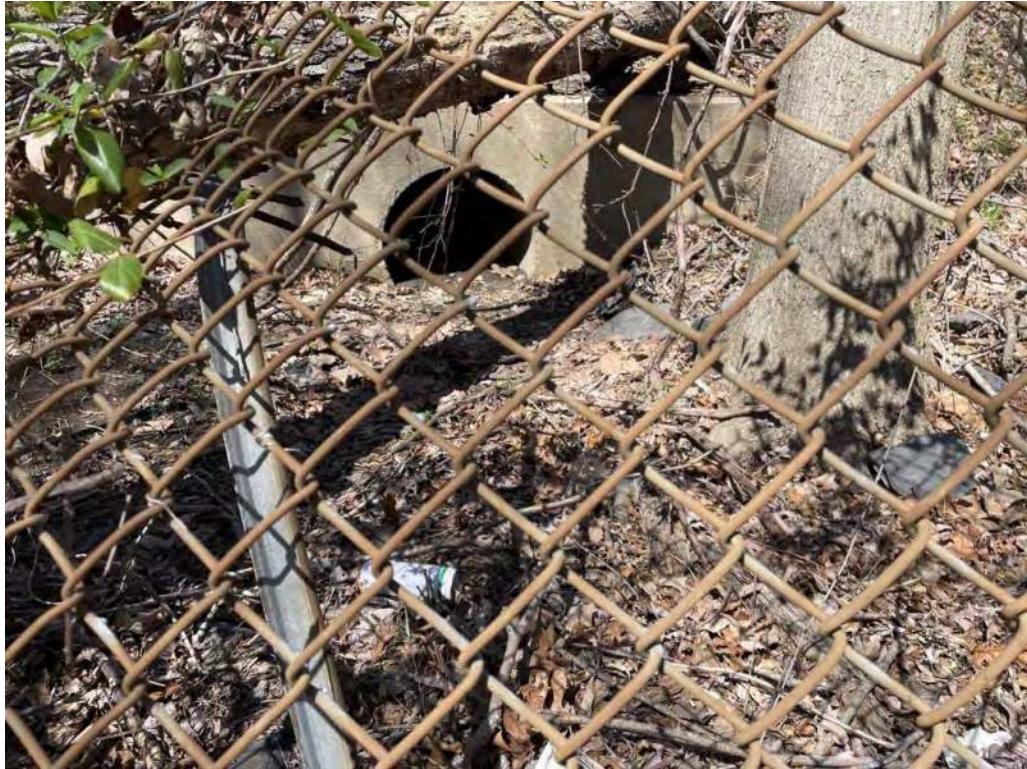
Photograph 9: View to the northwest showing the existing culvert at flag F-1, taken within the southwestern portion of the project site.

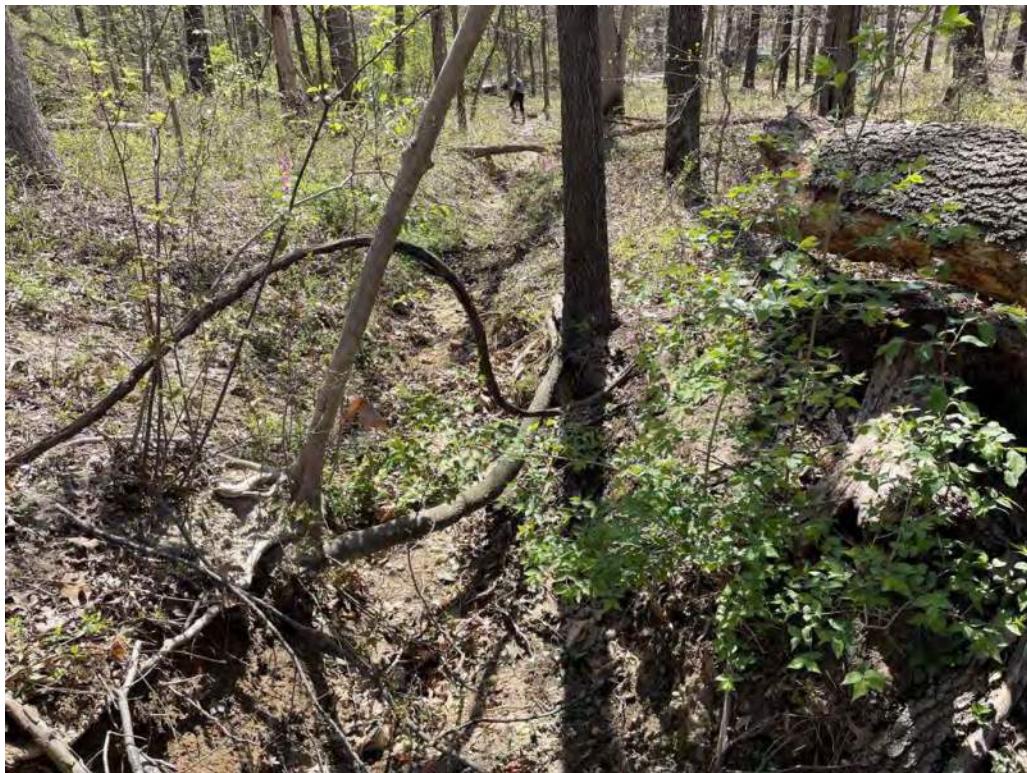
Photograph 10: View downstream to the southeast showing the ephemeral stream at flag F-1, taken within the southwestern portion of the project site.

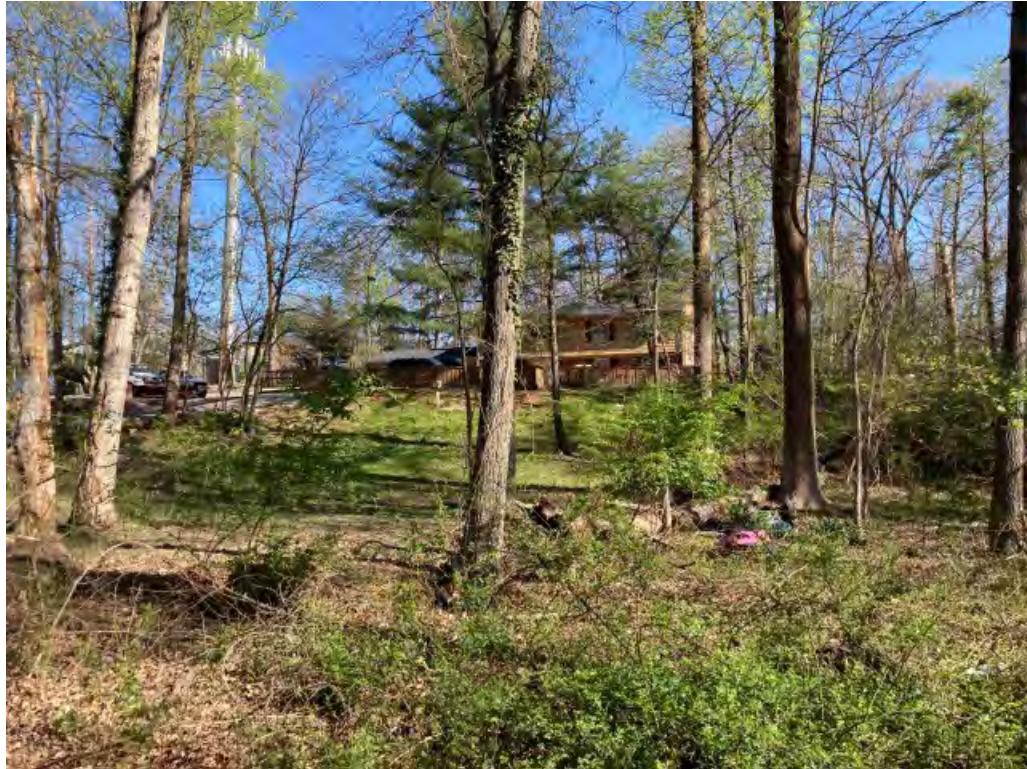
Photograph 11: View to the north showing the forested uplands and existing residence, taken within the southern portion of the project site.

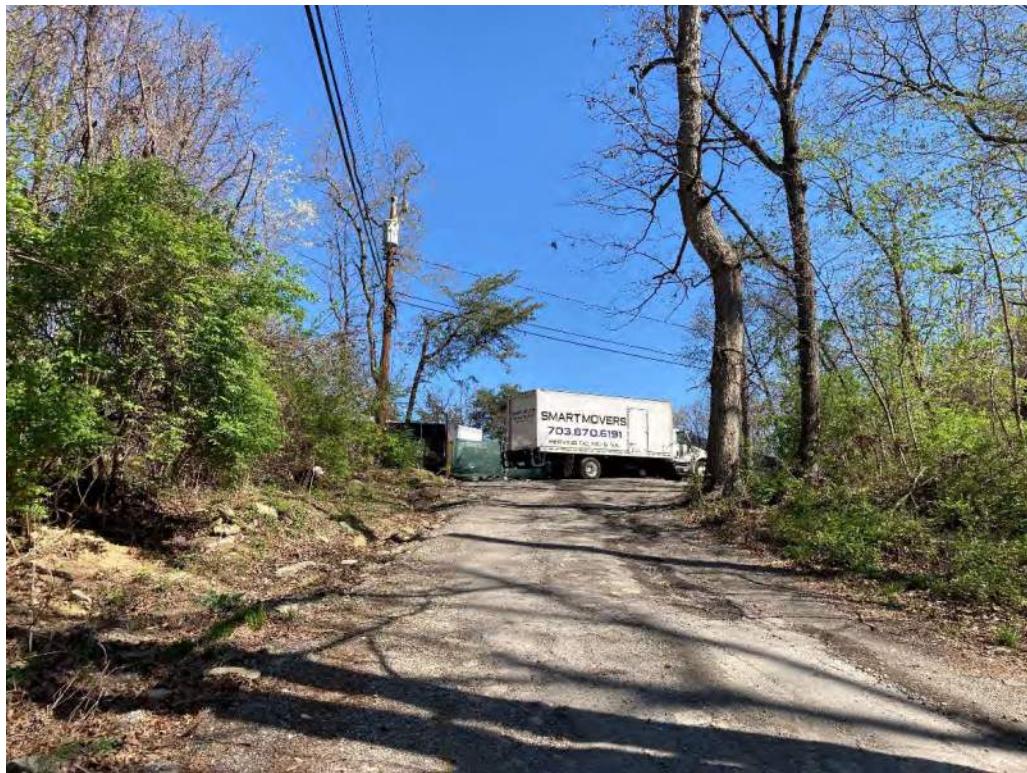
Photograph 12: View to the north showing the powerlines, existing driveway and parking lot for the automobile repair shop in the western portion of the project site.

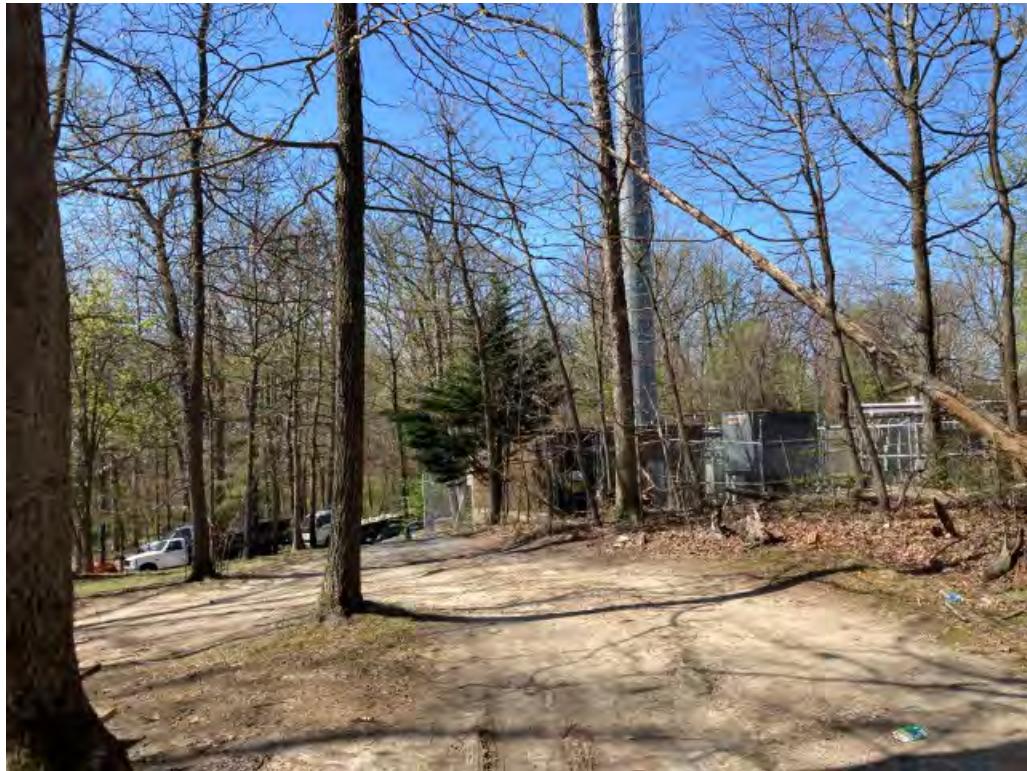
Photograph 13: View to the southwest showing the automobile repair shop, parking lot, and forested uplands, taken in the western portion of the project site.

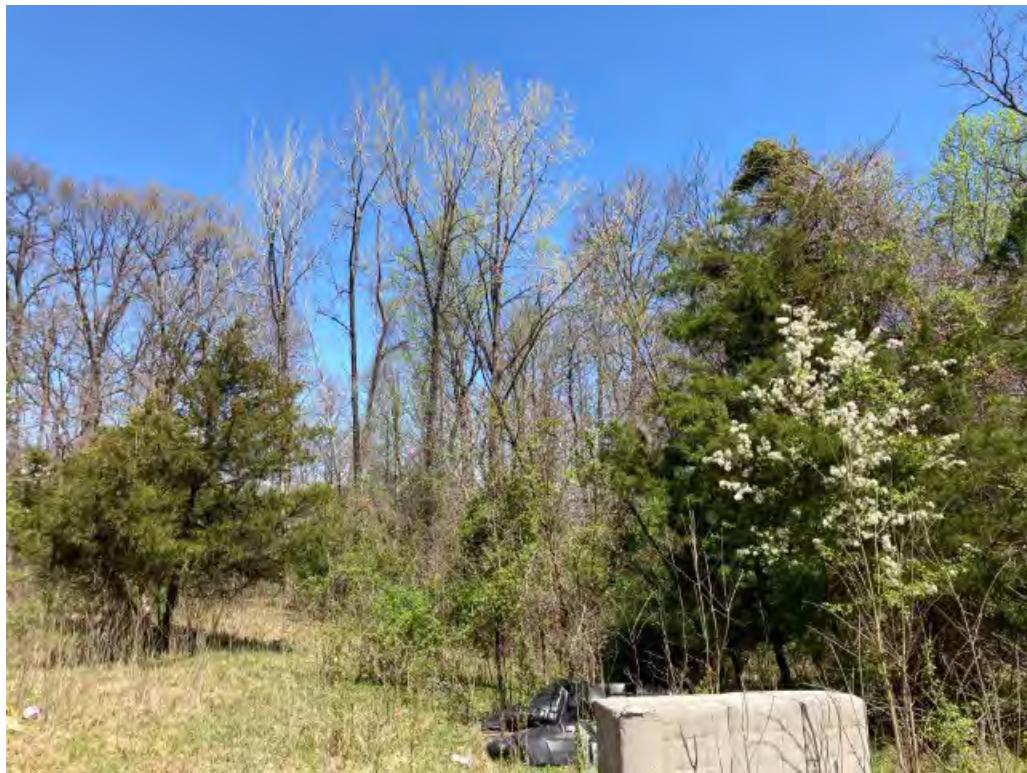
Photograph 14: View to the north showing the uplands and household debris within the northwestern portion of the site.

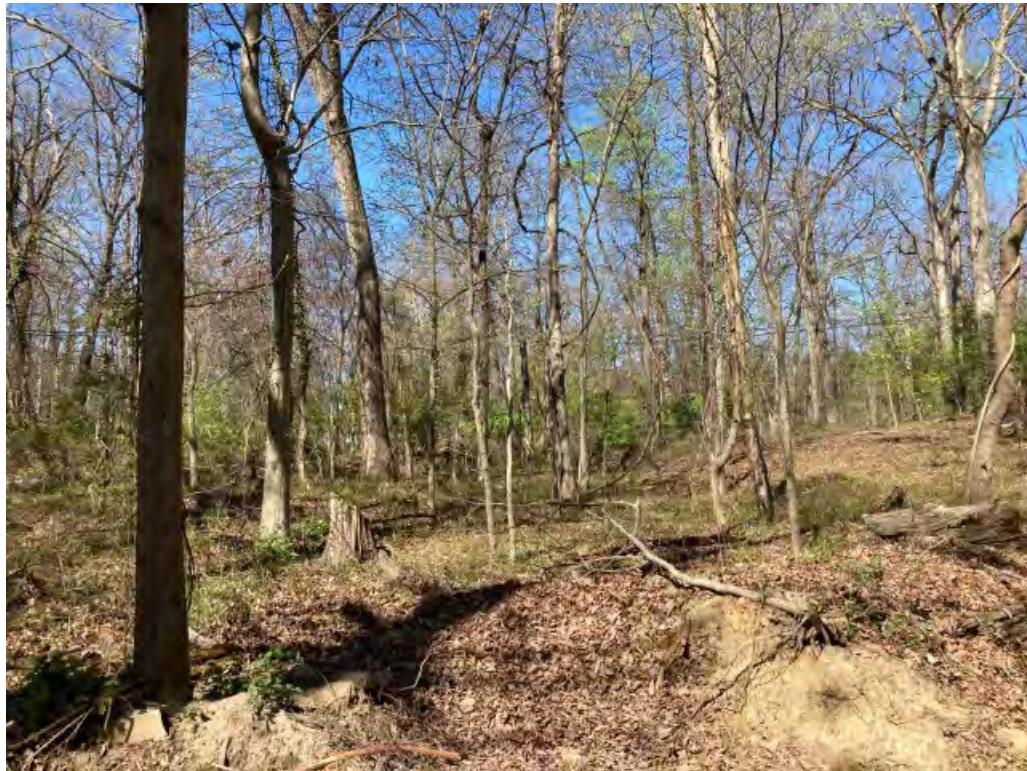
Photograph 15: View to the west showing the forested uplands within the southern portion of the project site.

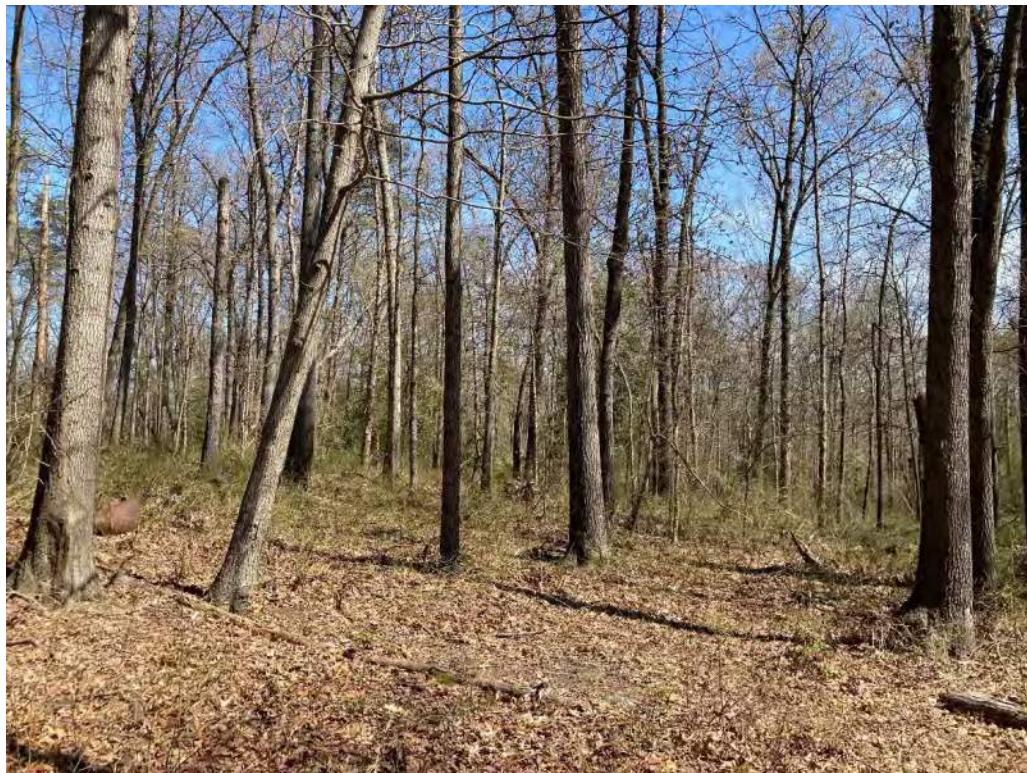
Photograph 16: View to the east showing the forested uplands within the northeastern portion of the project site.
