WETLAND DELINEATION REPORT
CORRIDOR CENTER
CITY OF LAUREL, MARYLAND

TNT PROJECT NO.: 2807

PULTE GROUP

JULY 11, 2022

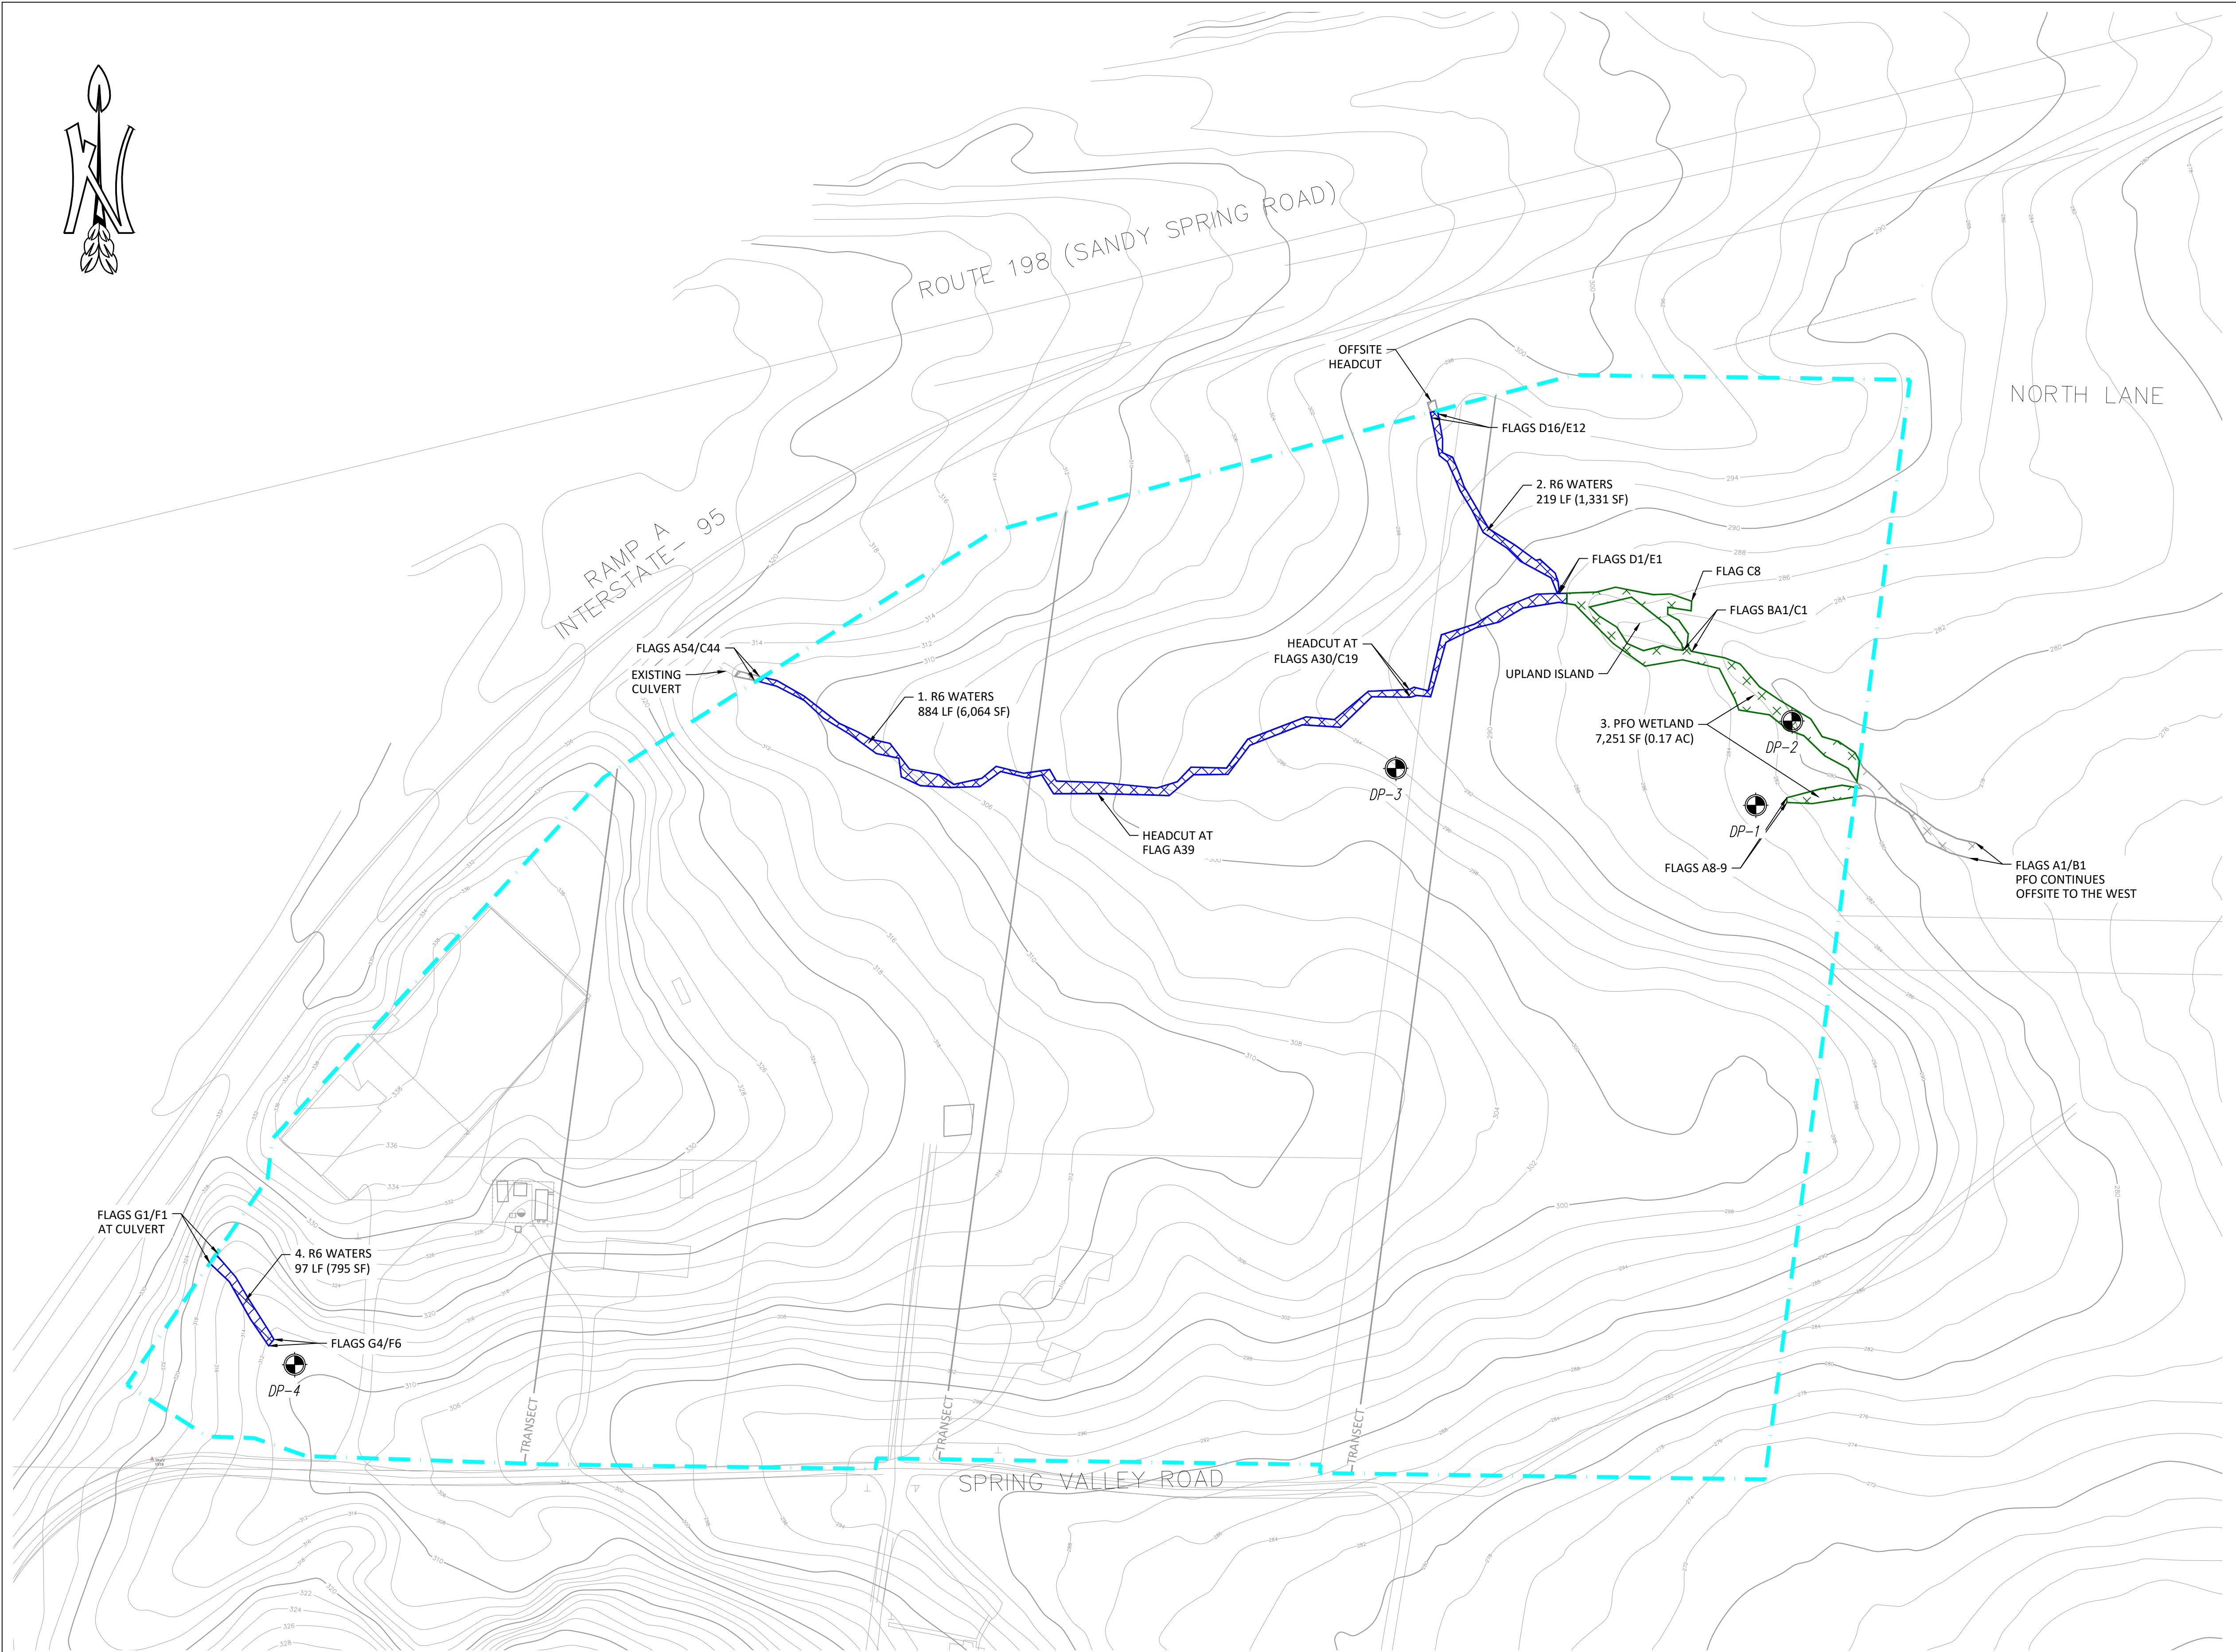
WETLANDS AND WATERS OF THE U.S.
DELINEATION MAP

Based on our field reconnaissance, TNT has identified and located wetlands and other Waters onsite. Wetlands identified on the project site are classified as palustrine forested (PFO). The main sources of hydrology for these wetlands include precipitation and high groundwater table. The wetlands are underlain by Aquasco silt loam (ApB) soil. Other waters on site include ephemeral (R6) streams located in the northern and southwestern portions of the site.

SUMMARY OF FEDERALLY JURISDICTIONAL WATERS (INCLUDING WETLANDS)				
AR ID	PFO (SF)	PFO (AC)	R6 (LF)	R6 (AC)
1	-	-	884	0.14
2	-	-	219	0.03
3	7,251	0.17	-	-
4	-	-	97	0.02
Total	7,251	0.17	1,200	0.19

AR- Aquatic Resource; PFO - Palustrine Forested; R6 - Ephemeral Stream
